# GXW4216 V2/GXW4224 V2/GXW4232 V2/GXW4248 V2

## Firmware Release Notes

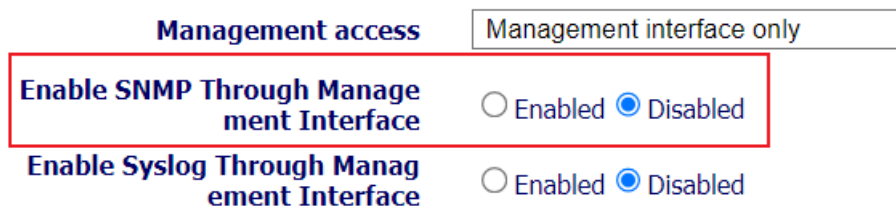
- **Web Configuration**

User can find the configuration in Web UI -> Maintenance-> Network Settings.

Management access Management interface only

**Enable SNMP Through Management Interface**  Enabled  Disabled
