GXW4216 V2/GXW4224 V2/GXW4232 V2/GXW4248 V2

Firmware Release Notes

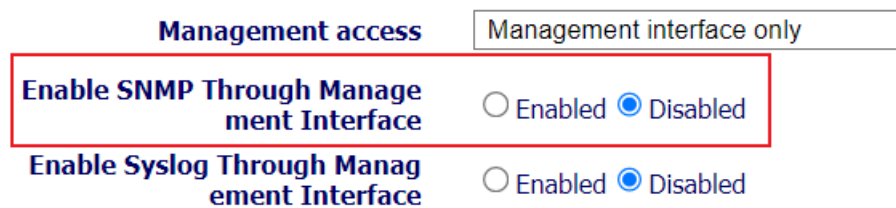
User can find the configuration in Web UI -> Maintenance-> Network Settings.

The screenshot shows a configuration page with a tab labeled 'Management access' and a dropdown menu set to 'Management interface only'. Below this, there are two radio button options: 'Enable SNMP Through Management Interface' (which is highlighted with a red box) and 'Enable Syslog Through Management Interface'. Both options have 'Enabled' and 'Disabled' radio buttons, with 'Disabled' being selected for both.
